The influence of the erosion process in the coastal zone of Olimp-Vama Veche

Ichinur Omer*, and Sunai Gelmambet

Ovidius University of Constanta, Faculty of Construction, Str. Union no. 22B, Constanta

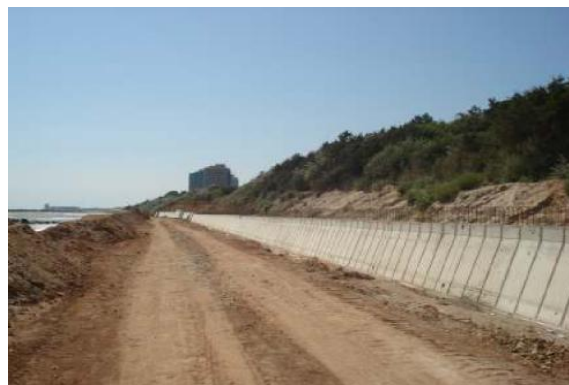
The beach of the Olimp resort is small, being made up of bays protected by three dikes from the anchorages. The embankments are deteriorating, requiring repairs and strengthening. The protective dikes have proven effective, protecting the beach against erosion. Works are proposed to remove some of the existing structures to widen the bays, rehabilitate, improve and build new protective structures and sand the beach (Sunai and Ichinur, 2013; Omer *et al.*, 2015; Văidianu *et al.*, 2020). Works were carried out to protect and strengthen the cliff in the northern area of the Olimp resort by building a retaining wall with a length of 630 m and a height of 5 m (Figure 1).

Figure 1. Works to strengthen the Olimp cliffs

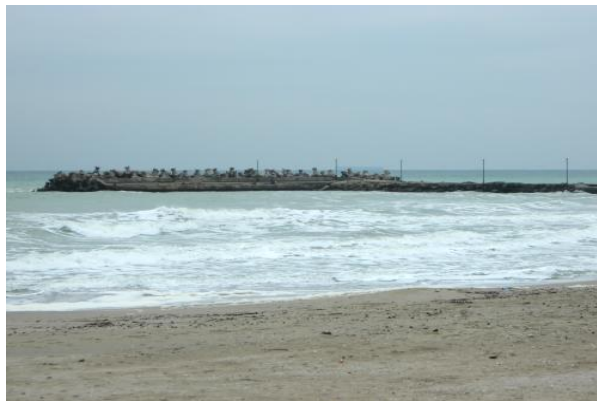
and are induced by the existence of breakwaters and other coastal development works. The beaches are narrow and underfed with sediments. The main sources of beach sediments are shells and fragments of limestone eroded from the seabed. The dynamics of beaches is almost entirely controlled by human intervention, but, in general, beaches are narrow and erode due to the lack of new sediment inputs and structures about to fail (Sunai and Ichinur, 2013; Omer *et al.*, 2015; Văidianu *et al.*, 2020). Along this area, between Pescarie Tatlageac and Hotel Silvia, there is a succession of controlled and artificially maintained beaches. These beaches are protected by modified breakwater structures and artificial headlands, with occasional offshore reefs. On the Olimp-Neptun shore area, there are six detached sea dikes and one submerged sea dike, parallel to the shore. The dikes show signs of degradation (Figure 2).

Figure 2. Neptune Bridge

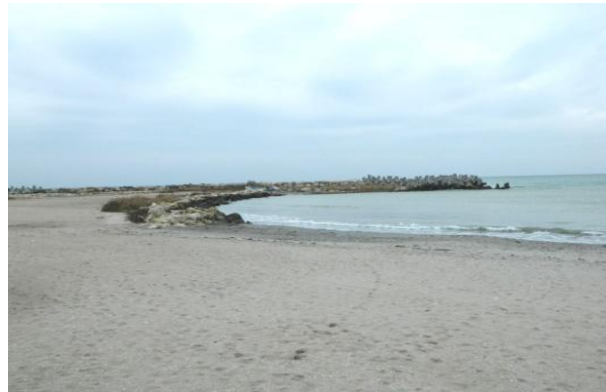
At Jupiter, Cape Aurora and Venus, there are a number of enclosed bays, protected by modified breakwaters and artificial headland structures with occasional offshore reefs (Figure 3 and Figure 4).

From place to place there are stone outcrops and seawalls behind the beaches, generally narrow. The piers are made of anchors and protected with stabilopos. The shore of Cape Aurora (between Jupiter and Venus) includes a succession of breakwaters and a large submerged breakwater. This resulted in the creation of a series of small artificial bays. In general, the beaches are less narrow in the southern area of Venus resort where there is a wide beach. The beaches suffer a slight erosion, and the protective structures show degradation.

Figure 3. Pier from anchorages in Cape Aurora

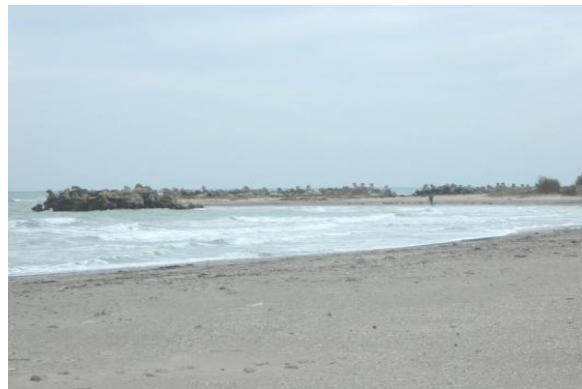
Figure 4. Dike from anchorages with stabilopods. in Venus

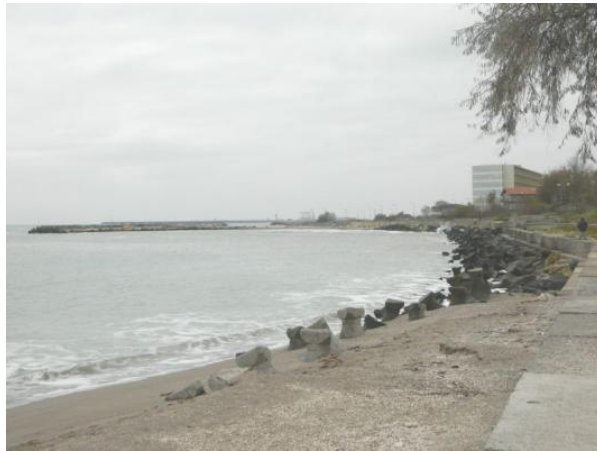
Moreover, an accretion phenomenon is manifested in the area opposite the direction of coastal alluvial transport near the Mangalia dike, which forms the southern border of this area. In general, the cliffs do not show instability, and in areas with erosion, works to

strengthen and protect the cliffs are foreseen (Figure 5). Rehabilitation and improvement works of the existing protections are proposed.

Figure 5. The jetty on the southern side of Saturn beach

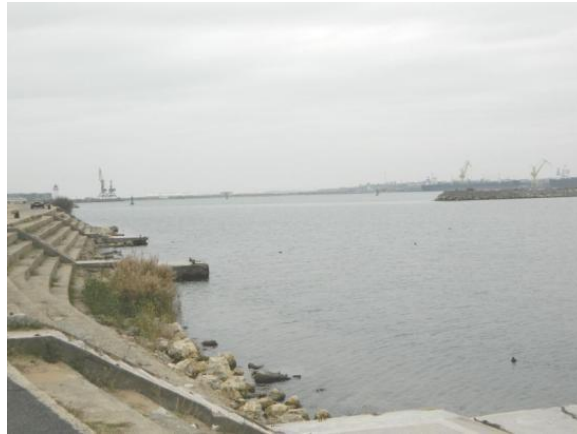
There are dikes made of anchorages protected with stabilopods that delimit the semicircular beach. On the northern side, the dike is T-shaped, and on the southern side it is Y-shaped. In the northern part, the beach narrows and is protected by anchorages. The shelter piers of the port of Mangalia and the tourist port are made with a core and protective mantles made of anchors, and in the offshore area they are protected with stabilopod shells. At the top of the shelter piers there is a concrete crown slab along the entire length of the pier. The sheltering dikes of the port of Mangalia have in turn affected the transport along the shore and the general circulation of the sediments, some of them being transported out to sea. The port of Mangalia influences the erosion of the cliffs and beaches between the villages of 2Mai and Vama Veche. Like other ports located on this section of the coast, Port Mangalia constitutes an impermeable boundary for the transport of sediments. Immediately south of the breakwater there is a small strip of stable or slightly growing beach, several tens of meters long. This represents a small sedimentary basin as an effect of sheltering and produces an impact on the offshore waves generated by the Mangalia port breakwater. There is erosion in the northern part of the beach and deposits in the southern part as an effect of the delimiting dikes beach. For this reason, a stone protection was created in the northern area of the beach (Figure 6). Repair works and improvement of the existing protections are proposed. Artificial beach sandbanks, 20m wide between the piers in front of the President Hotel (Văidianu *et al.*, 2020).

Figure 6. Dikes in Mangalia

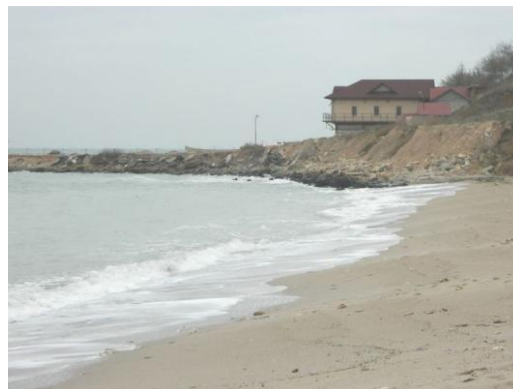
There is a breakwater made of stone and reinforced concrete elements in an advanced state of decay. Otherwise, there is no coastal protection. Next to the second golf beach from 2Mai, direction the alluvial transport changes suddenly, the influence of the breakwater dikes is reduced, and the longitudinal alluvial transport resumes its general southern course. Compared to the 1960 and 1979 maps, there are major changes in the appearance of the shoreline in this area. Due to the breakwater sheltering the port of Mangalia, there is a strong erosion of the beaches, and the waves reaching the base of the cliff cause collapses, endangering the nearby constructions (Figure 7).

Figure 7. Erosion of the beach and the cliff on 2Mai

Works are proposed to rehabilitate the existing dike and protect the base of the cliff, where appropriate, together with measures to reduce the impact on habitats (Sunai and Ichinur, 2013; Văidianu *et al.*, 2020).

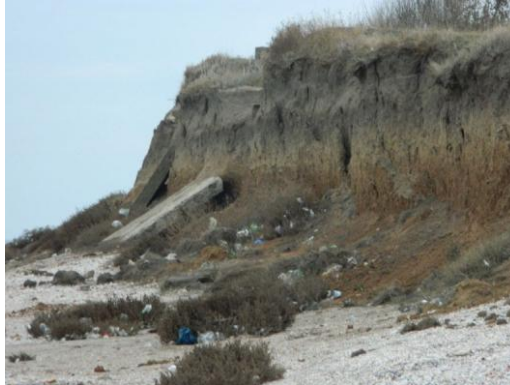
There are no hydrotechnical constructions or coastal protection elements. This area stretches to the Romanian border with Bulgaria. The area includes cliffs and a sandy beach. The beach is subject to erosion and the cliff is susceptible to landslides (Figure 8).

Figure 8. Erosion of the cliff at Vama Veche
